Fish Creek Restoration Management Plan

2019

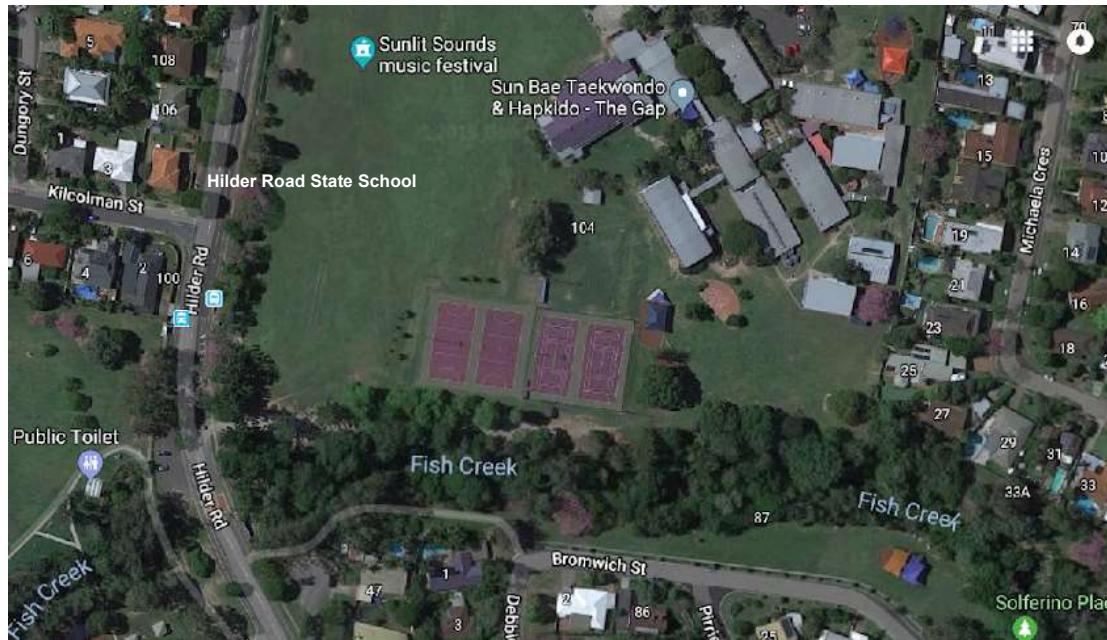
Figure 2 Aerial image of Fish Creek forming the southern boundary of the Hilder Road State School property boundary

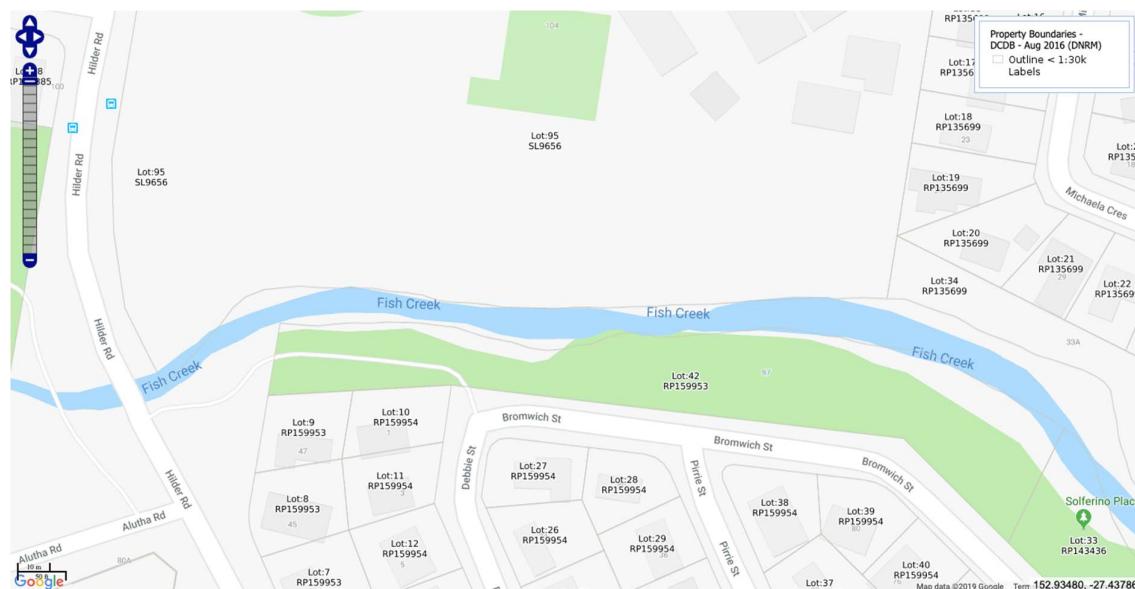
Figure 3 DNRME mapping of Land Tenure (2016) showing HRSS (Lot 95 Plan SL9656) with Fish Creek at the southern boundary

Fish Creek forms the southern boundary of HRSS and is mapped by the Queensland Department of Natural Resources, Mines and Energy (DNRME) as “Unallocated State Land” under the trusteeship of BCC (Figure 3). As such, the tenure is regulated by BCC on behalf of the Queensland Government, and any development occurring within the Creek is subject to local and state approvals.

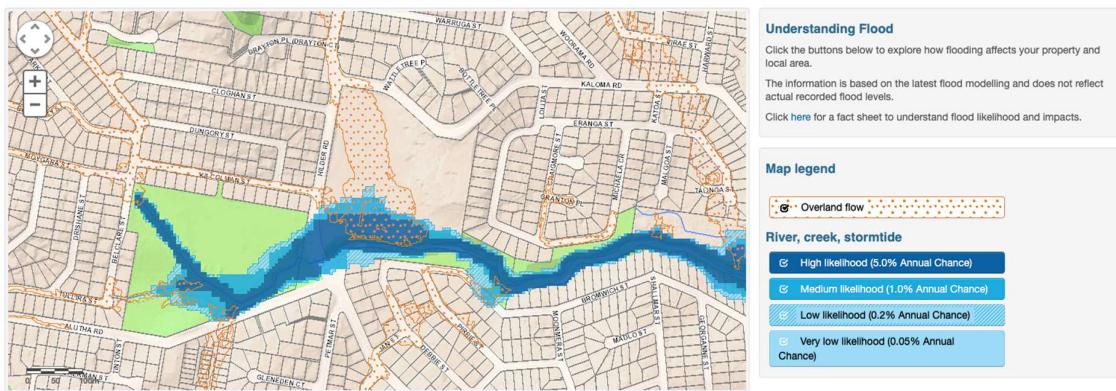
Figure 4 BCC mapping of likelihood of flooding at the HRSS and Fish Creek (BCC, 2019)

Fish Creek is mapped on BCC's Flood Awareness Map (2019) as having a 'high likelihood' (5%) of annual flooding, with much of the HRSS grounds included in the mapped overland flow (Figure 4). As such, there will be significant limitations on the extent of work that can occur within the Creek footprint. This will include no permanent structures (such as constructed pathways, boardwalks or platforms).

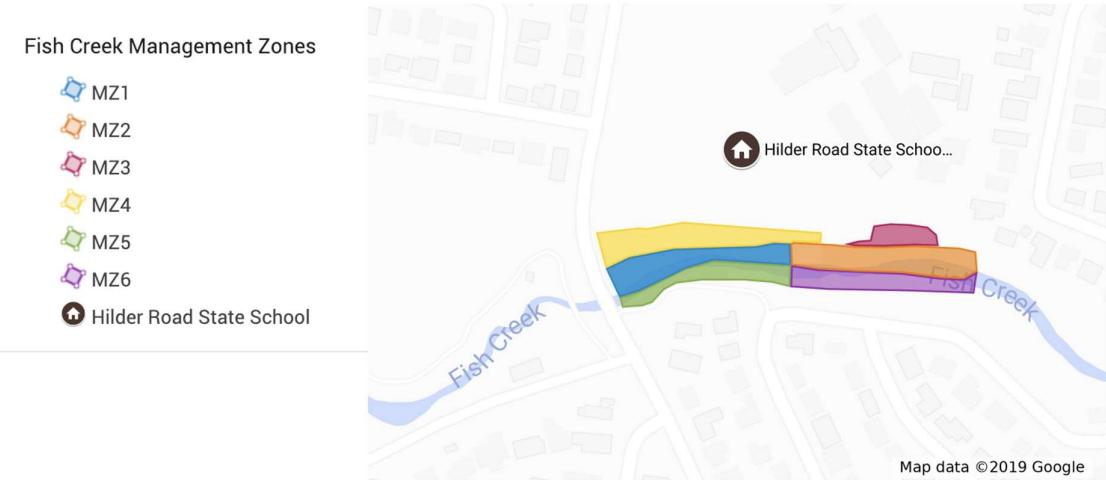
Figure 5 Management zone map of the Fish Creek restoration project

For ease of programming the Project, and to enable the work to be delivered in smaller, easier to manage packages, Fish Creek has been divided into six management zones (Figure 5).

Each management zone is described below:

Management Zone 1 (MZ1): West Fish Creek - North Bank

MZ1 comprises the area subject of previous grants that has been cleared of weeds. The area has been under a weed management program for approximately two years and a pathway has been cleared to the mid-point of the Creek. The area boundary includes the fence line that separates the creek from the school grounds to the northern bank of Fish Creek to the centre line of the channel. The western boundary is Hilder Road and the culvert, and the eastern boundary is the mid-point of the Creek as it sits on the school property. This is marked by the netball courts and west of the storm water drain.

Management Zone 2 (MZ2): East Fish Creek - North Bank

MZ2 comprises the area east of MZ1, from the centre point of the creek as it occurs on the school boundary, to the east of the school where the school boundary finishes. It includes the north bank of the creek to the centreline of the creek channel. The area has not had any management treatments applied previously and is currently not accessible due to dense weed cover. The area includes a storm water drain, a spoil pile from previous construction activities near the creek (likely the netball courts), and is bounded in the north by the fence line.

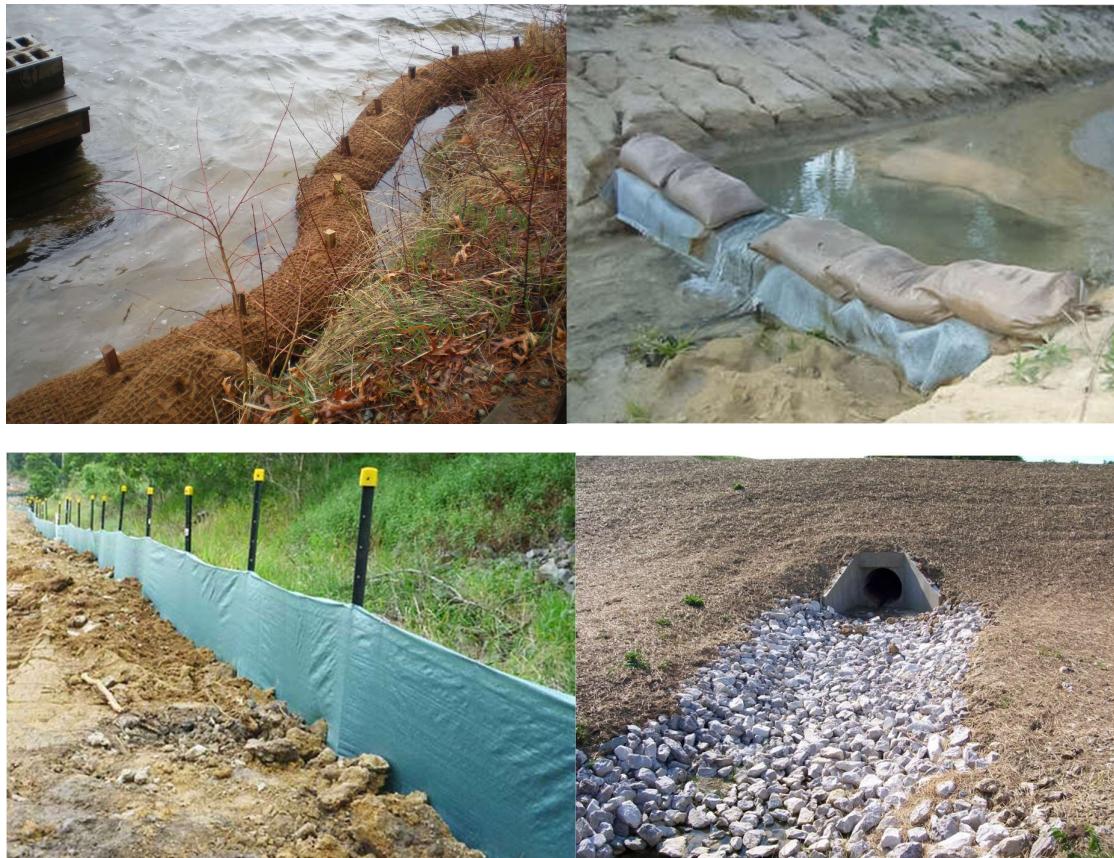
Figure 6 Examples of erosion and sediment controls. Top left: coir logs; top right: sand bags; bottom left: sediment fencing; bottom right: rock chute

- Coir logs
- Sand bags
- Rock chutes
- Sediment fencing

These methods should be considered temporary and require maintenance to ensure they remain effective while in use.

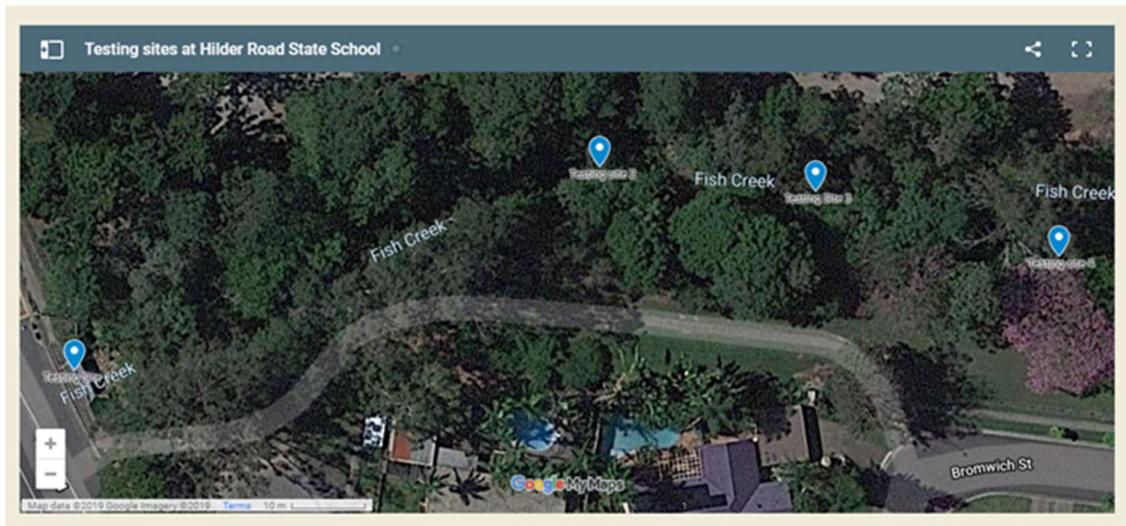
Water Quality testing has been completed since November 2016 at four data collection points along Fish Creek (see image below). The water quality data has been recorded on the www.fishcreek4061.com.au website for the HRSS parents and community to use for educational and scientific monitoring purposes. This will continue on an annual basis as long as the school continues to teach the amended Year 5 HASS (Geography) Unit 1 (see <http://fishcreek4061.com.au/2018/04/year-5-hass-geography/>) for more details.. The water quality
